# SURFACTANT-BASED EXTRACTION PRODUCT HELPS MINIMIZE IMPACTS FROM LARGE SPILL IN ALBERTA

By **George (Bud) Ivey** and **Adam Dunn**

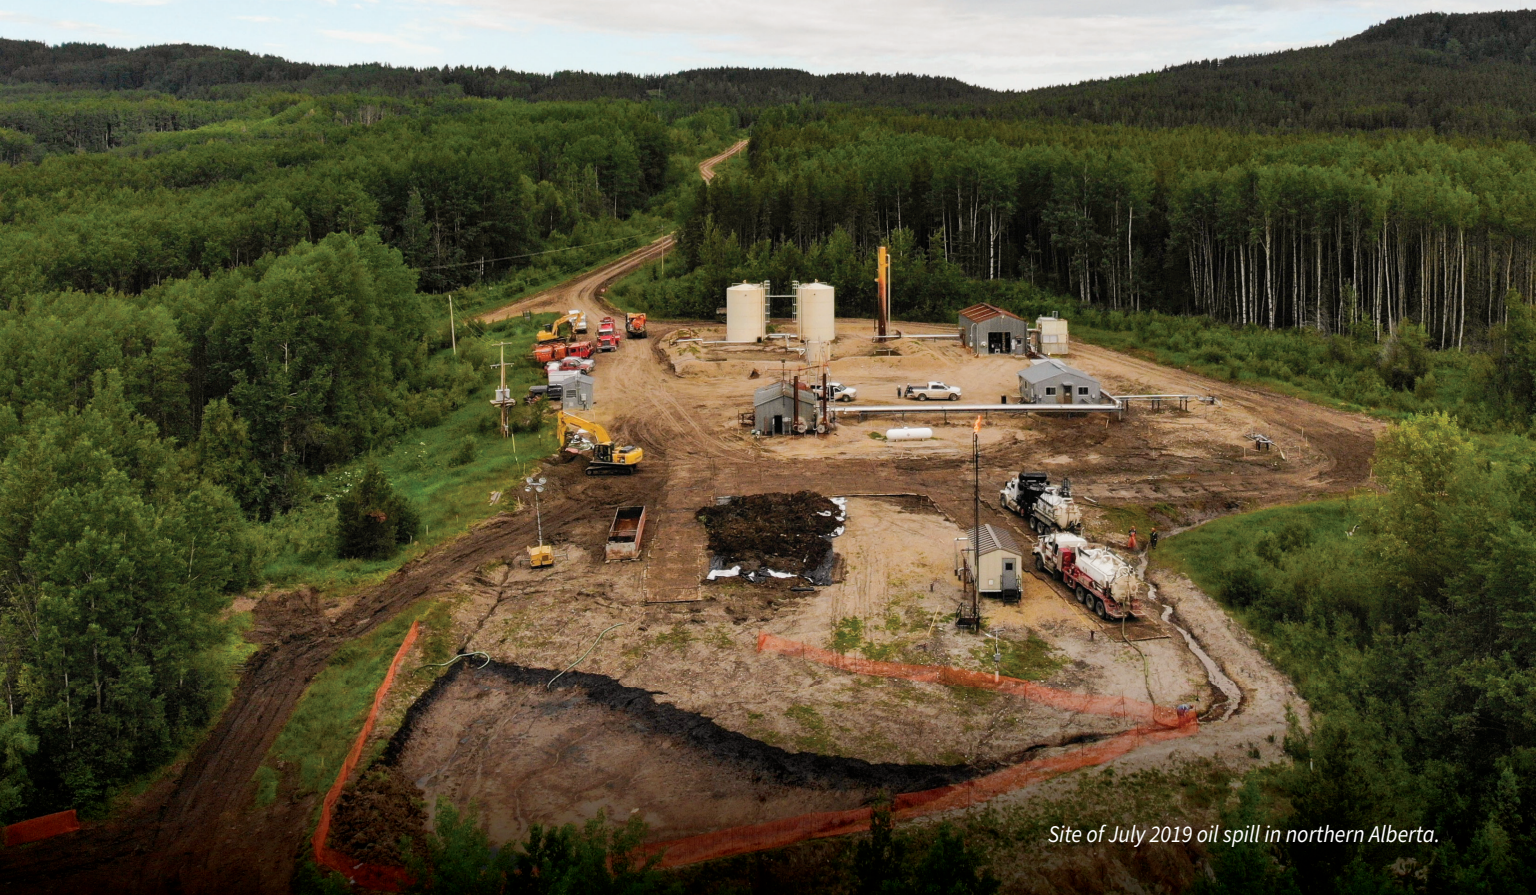
*Site of July 2019 oil spill in northern Alberta.*

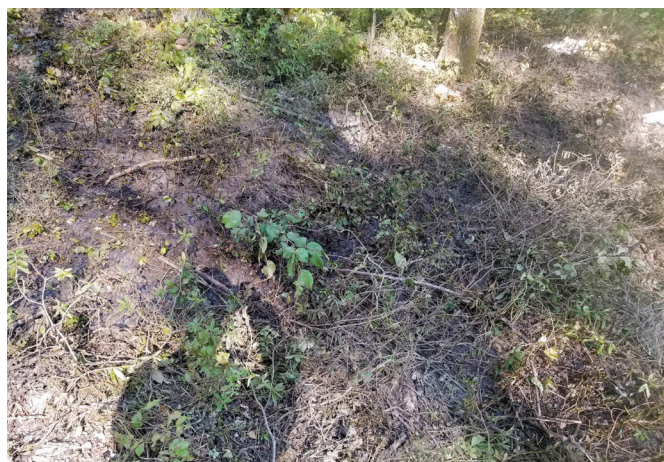
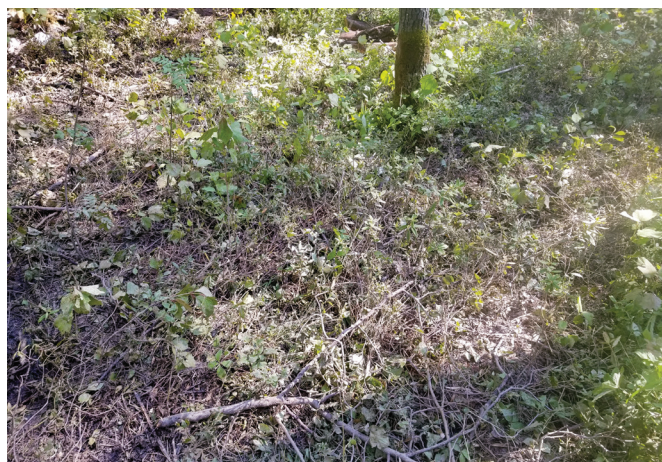
Views of area near Bell Hole 3 before and after flushing with the surfactant.

The surfactant was applied over the course of four days, and the majority of the oil on the hillside was effectively liberated and flushed into the trenches and bell holes for removal. Visual observations indicated that the cleanup operation was generally effective, and soil sampling confirmed these findings.

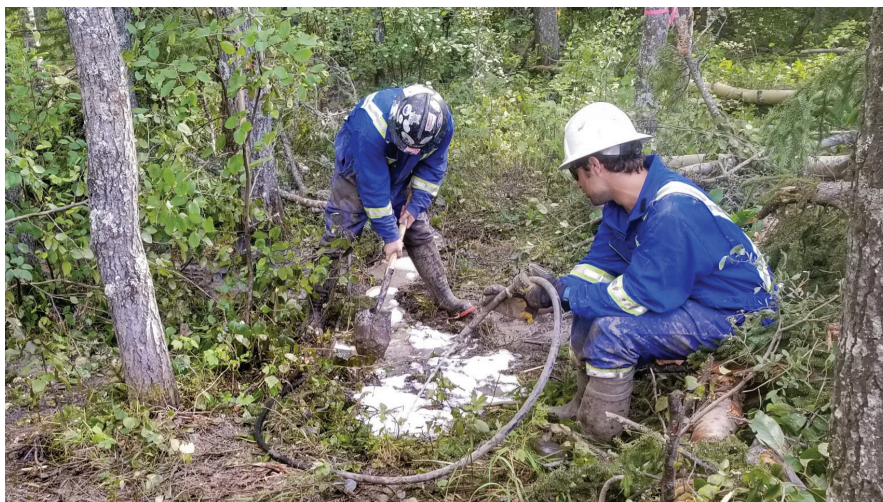
Cleanup crews flush forested impact site with Ivey-sol® surfactant.

At the spill site, the surfactant was deployed in varying concentrations, using various delivery methods in a roughly checkerboard configuration. The first trial was completed using backpack sprayers (with a surfactant-to-water ratio of 1:30), followed by pressure-washing.

There was not enough volume in this trial, however, to move the oil to the recovery bell holes for removal. In order to increase pressure and volume, the surfactant and water were mixed in the tank of a small hydrovac truck at a 1:40 ratio for the second trial and applied using the pressure wand. The oil could be recovered with this application with the right technique, but would splatter if too much pressure was used.

In the third trial, another surfactant-to-water ratio of 1:40 was mixed in the hydrovac truck tank, and the tank hose was used for application rather than the pressure wand. The surfactant effectively washed the oil off the vegetation using this application.

However, there was not enough pressure to move the fluid to the recovery bell holes, and suds were being produced. In order to optimize oil recovery and surfactant usage, ratios of 1:60 and 1:80 were applied and small local trenches were dug to collect and recover fluids.
